**REVIEW OF HR-73C CONFIGURATION  
DEVELOPMENT PROGRAM  
MARCH - DECEMBER 1958**

**Engineering Report Number 5364**

**12 January 1959**

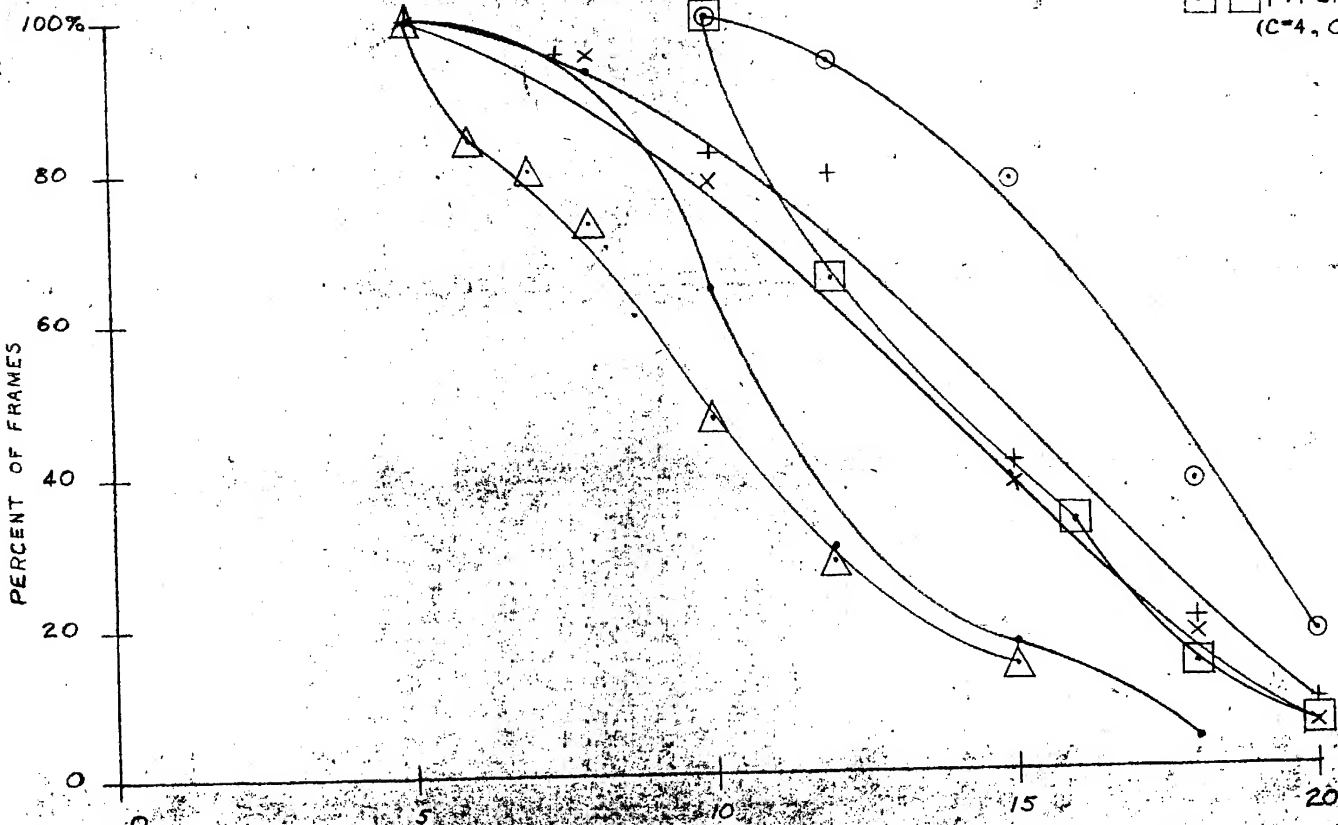
FIGURE 1: S-CURVES

The flight test program, scheduled for completion on 1 August, con-  
tinued until 15 August due to a delay in the availability of the test vehicle.  
Four tests were conducted, of which the last two achieved good focus. The re-  
sulting photographs showed a substantial improvement over previous results <sup>7</sup>  
(see figure 1), and the oscillographic records of in-flight vibration indicated  
that reduction to tolerable levels had been achieved. <sup>8</sup> It was also concluded  
that some additional work should be done to improve stabilization and IMC. <sup>9</sup>  
Furthermore, some additional areas required investigation, but it was believed,  
if reliable operation could be quickly established, that the configuration was  
ready for operational commitment, so that operational problems could be assessed.  
The subcontractor stated that the configuration was now capable of reliable op-

It is difficult to assess the performance improvement in quantitative terms, since to a large measure it is still a matter of opinion. However, the consensus seems to be that resolution was brought up to a level of approximately 15 to 18 lines per millimeter from a level of about 8 to 10 lines per millimeter.
